Fan Diagnosis in the Field

A. El-Shafei
RITEC
Cairo, Egypt

SYNOPSIS

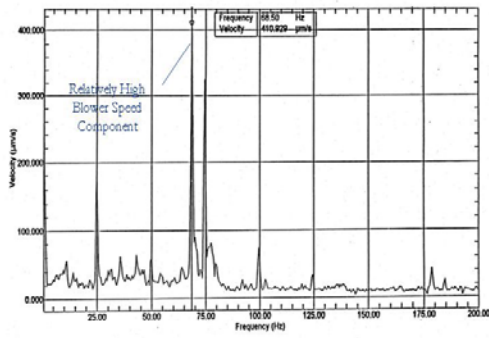
Figure 3 Motor Drive End Spectrum

On investigating this machine, the bearing failure rate was at a rate of once every two to three weeks. Spectral measurement on the machine confirmed that the motor had no malfunction, but the axial vibration is relatively high at the speed of the blower. Figure 3 shows the spectrum of the motor drive end bearing with high vibration at the speed of the blower. The motor was driving through a flexible coupling, a speed increaser gearbox mounted on journal bearings. The gearbox was driving the blower at 4000 rpm through a flexible coupling. The blower was overhung and mounted on two journal bearings. Survey of the blower and the gearbox showed a high axial component at both the gearbox and blower bearings at the speed of the blower. Figure 4 shows a typical gearbox spectrum. The gearbox showed a high gear mesh frequency of 1966 Hz and a high twice gear mesh frequency. Also, impacting was quite clear at a natural frequency of 2365 Hz with side bands. The highest vibration levels were at the vertical and axial directions of the blower bearings and were reading 5.2 mm/s.

The diagnosis of this sensitive machine was as follows: The blower is experiencing a couple unbalance producing an axial force that is providing an impacting on the gearbox and deteriorating the gear meshing. This axial force is then transmitted to the electric motor causing the bearing failure. The recommendation was to inspect the gearbox, correct any problems, and to balance the blower.

The gearbox was replaced, the blower bearings and shaft were replaced, and the motor bearings were replaced. The machine showed reduced overall vibration, but balancing was still recommended. The vibration vectors showed the need for a couple shot. A trial weight of 10 gm was used with this sensitive machine that was trim balanced with a 3 gm shot. The highest vibration level was reduced to 1.2 mm/s. No motor bearing failures have been reported since.

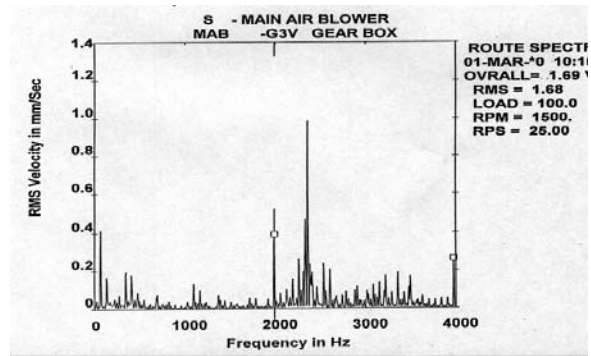
Figure 4 Gearbox Spectrum

The gearbox was dismantled; the drive end journal bearing on the gearbox was completely destroyed. The axial thrust collar on the gearbox and on the blower bearings showed clear signs of impact. The blower bearings showed excessive clearance and rubbing on the rotor and bearings.

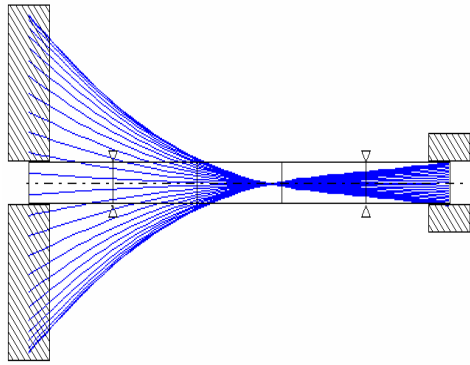
Figure 5 Mode Shape of the Fan.

From this Table it is clear that the machine is approaching resonance as its speed increases. A computer model was developed on RIMAP, a rotordynamics package [7], and it was determined that resonance occurs at the maximum speed of the machine. The mode shape is shown in Figure 5. Yet, it was decided to balance the machine. Inspection of the results of the run-up test show that the machine exhibits vibration that is in phase at both bearings at nearly all speeds, even though it exhibits a conical mode at resonance.

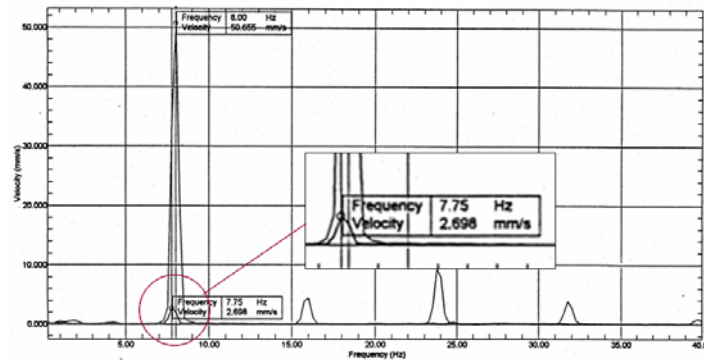
Figure 7 Spectra before and after balancing showing significant reduction

1600 KW DC motor. The maximum speed is 490 rpm. Production required the machine to be operating at 95 % of its max. speed, while because of the high vibration the machine was operating at 82 % of its max. speed. The 4 meter high foundation showed visible cracks. Vibration measurements on the non-drive bearing showed a whopping 290 mm/s level, mainly at 1x.

Before balancing it was requested to clean the fan blades, the vibration levels were reduced to 50 mm/s. A run-up test was performed to try to determine if any resonant conditions occurred and to mitigate any undesirable effects from the skid and foundation. Table 1 illustrates the results of the run-up test.

It was decided that the machine only needs a Static balance because of the in-phase measurement. A trial weight of 2 kg barely made the machine respond, but was used to obtain the balance sensitivity. The machine was finally balanced by a 6.1 kg weight, as shown in Figure 6, after removal of the trial weight. The vibration was reduced to 2.7 mm/s, and has been performing satisfactorily for over a year now. Production can now attain whatever speed they wish to load the kiln. Figure 7 shows the vibration spectra before and after balancing.

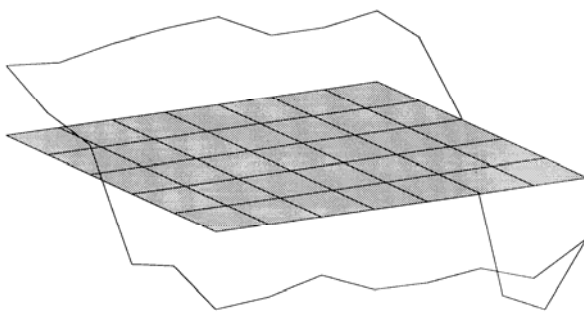
Figure 8 Vertical ODS Showing Rocking of Skid

Upon successful balancing, it was required to investigate the skid resonance problem. An ODS of the skid was measured. Figure 8 shows a clear rocking motion for the skid in the vertical direction, while Fig. 9 shows a clear swaying in the skid in the horizontal direction. These measurements increase in amplitude as the machine speed increases and approaches resonance. Apparently the long period at which the fan was operating with severe unbalance resulted in the I-beams, embedded 0.8 m in the foundation and carrying the skid, separating from the concrete. A finite element model of the skid and foundation was developed and a suitable supporting structure was designed and implemented to prevent the rocking and swaying and to increase the natural frequency well beyond the operating speed of the fan.

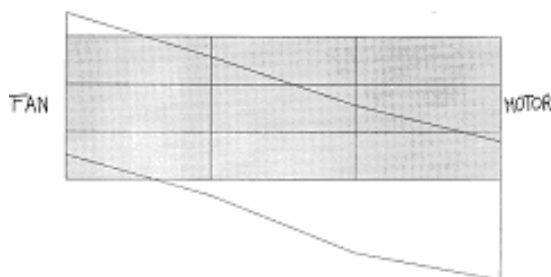
Figure 11 Base Plate ODS-Horizontal Direction

Upon investigation of the problem, and applying the diagnostic procedure shown in Figure 1, a spectral analysis indicated that no bearing faults were present, and no unbalance, but the main exciting frequency is at 6x (blade passing frequency). However, investigating the operating conditions, it was clear that the blade angles were correct and the blade clearance was also set correctly. Therefore aerodynamic excitation was eliminated as a cause of the problem. A bump test was conducted, but was not conclusive because of transmitted vibration and it was not possible to shut down all coolers at the same time. An ODS was conducted at 6x, the exciting frequency, and the results are shown in Figures 11 and 12. It is seen quite clearly that the main deflection occurs in the middle of the frame, right where the repeated failure occurs, both in the horizontal and vertical directions. The reason of the failures is quite clear: the flexibility of the supporting structure at the gearbox input shaft position results in shaft failure. Increasing the shaft diameter only transmitted the problem to the gearbox, resulting in the accelerated wear. The root cause of the problem is the flexibility of the supporting structure. This supporting structure should be stiffened.

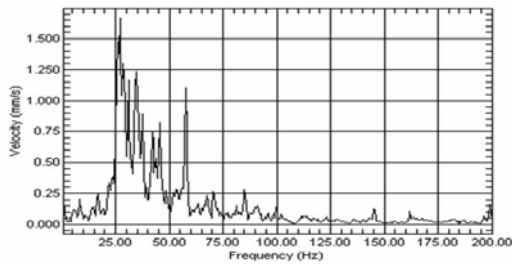
Figure 13 Drive End Bearing Spectrum

This is an unusual case. During acceptance testing of a cement plant, the vibration levels were relatively high for a new fan operating on rolling element bearings. The spectra are shown in Figures 13 and 14.

Applying the diagnosis procedure shown in Figure 1, no bearing frequencies were found, no installation faults were found, and the fan was well balanced. Also no vibration at the blade-pass frequency was seen. However, the fan bearings were noisy. The vibration pattern shown in Figures 13 and 14 is not usually associated with bearing faults. Although the spectrum is noisy with significant energy and has many frequencies, yet none of the frequencies matches with the bearing frequencies, namely BPFI, BPFO, BSF and FTF. However, discussion with plant personnel revealed that welding was performed near the fan. This immediately made us reconsider our diagnosis. The pattern shown in Figures 13 and 14 is an indication of electric discharge on the bearings, and occurs when welding is performed without proper electrical isolation. The fan was stopped and the bearings were removed, and clearly the discharge marks were evident. The fan was running smoothly, after the bearings change, allowing its acceptance by the customer.
