Fan Diagnosis in the Field

A. El-Shafei
RITEC
Cairo, Egypt

SYNOPSIS

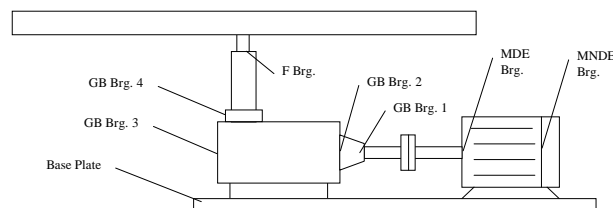
Figure 10 Schematic Layout of the Machine

This case study is from the petrochemical industry, and is for the supporting frame of a vertical air cooling fan supported on a horizontal steel frame with a horizontal motor and a bevel gearbox (see Figure 10). The unit is one of 12 units supported on an

elevated steel frame, used to cool air for 3 Gas Turbines 9 MW each. The units were experiencing frequent shear failures of the shaft connecting the motor and the gearbox at the input shaft of the gearbox. The manufacturer suggested the use of a larger diameter shaft. However, this resulted in accelerated wear in the gearbox.

Upon investigation of the problem, and applying the diagnostic procedure shown in Figure 1, a spectral analysis indicated that no bearing faults were present, and no unbalance, but the main exciting frequency is at 6x (blade passing frequency). However, investigating the operating conditions, it was clear that the blade angles were correct and the blade clearance was also set correctly. Therefore aerodynamic excitation was eliminated as a cause of the problem. A bump test was conducted, but was not conclusive because of transmitted vibration and it was not possible to shut down all coolers at the same time. An ODS was conducted at 6x, the exciting frequency, and the results are shown in Figures 11 and 12. It is seen quite clearly that the main deflection occurs in the middle of the frame, right where the repeated failure occurs, both in the horizontal and vertical directions. The reason of the failures is quite clear: the flexibility of the supporting structure at the gearbox input shaft position results in shaft failure. Increasing the shaft diameter only transmitted the problem to the gearbox, resulting in the accelerated wear. The root cause of the problem is the flexibility of the supporting structure. This supporting structure should be stiffened.
